Schafer Construction Project Summary

Project Name: 405 Business Park Building Repair

Existing Condition: Northwest corner building damage. A vehicle had damaged a corner of the building that affected two sides of a stucco exterior.

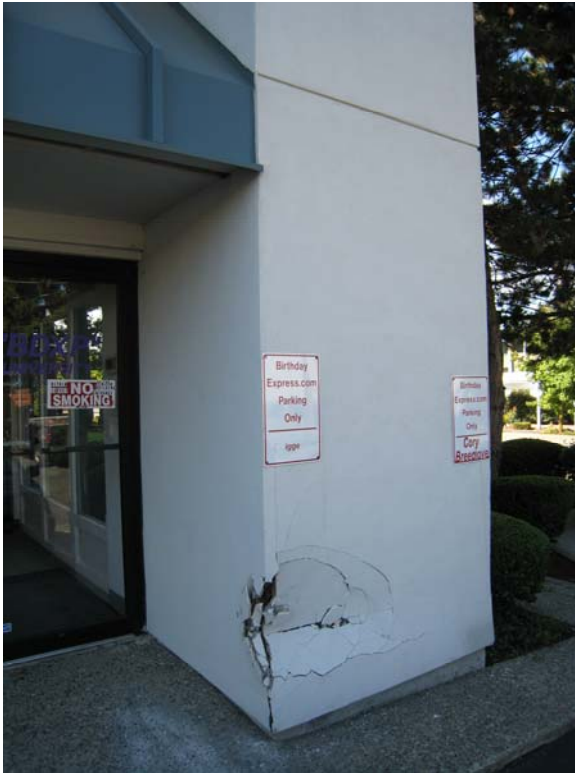
Description: Corner damage to the building stucco, OSB plywood and framing.

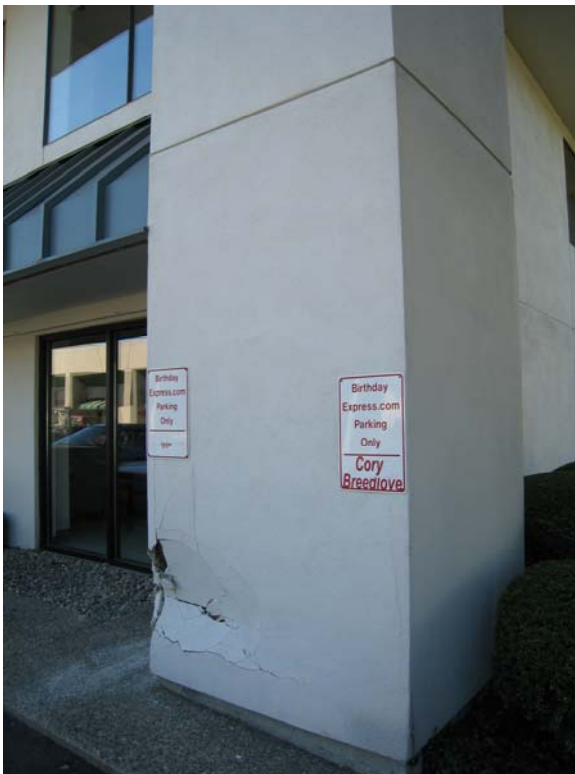
Description: Same as above.

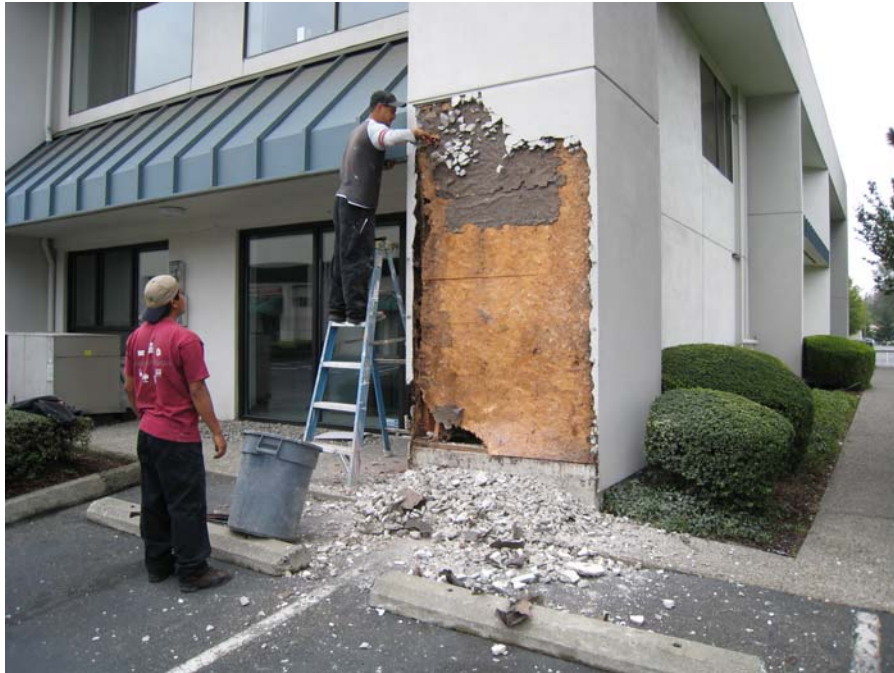
Description: Demolition of stucco system to repair area. As we found wood rot from a existing leak on the damaged corner the property management decided to repair the entire section.

DEMOLITION: Remove stucco and OSB board to expose damage to covered framing on 2 sides. During demolition we discovered some water intrusion problems that Schafer Construction immediately notified the property management. The management wanted Schafer Construction to repair water damaged OSB plywood on the entire panel which we did.

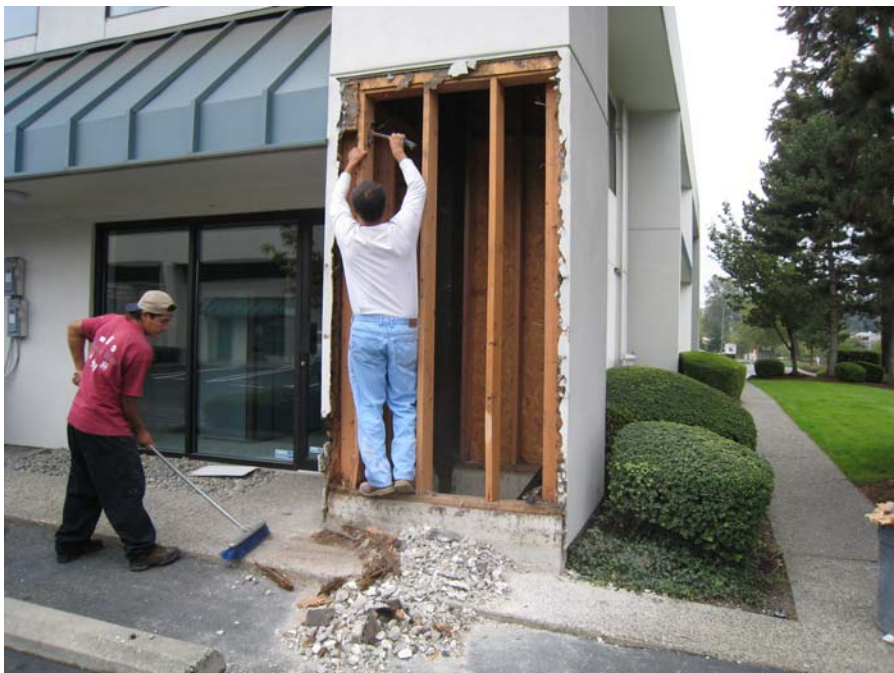
Description: Repair of wood framing.

REPAIR AND REPLACE: Repair damaged 2"x4" lumber on the adjoining corner to 2 sides, reface with OSB board, vapor barrier and re-install stucco exterior. Finish coat and texture was color matched to existing building finish.

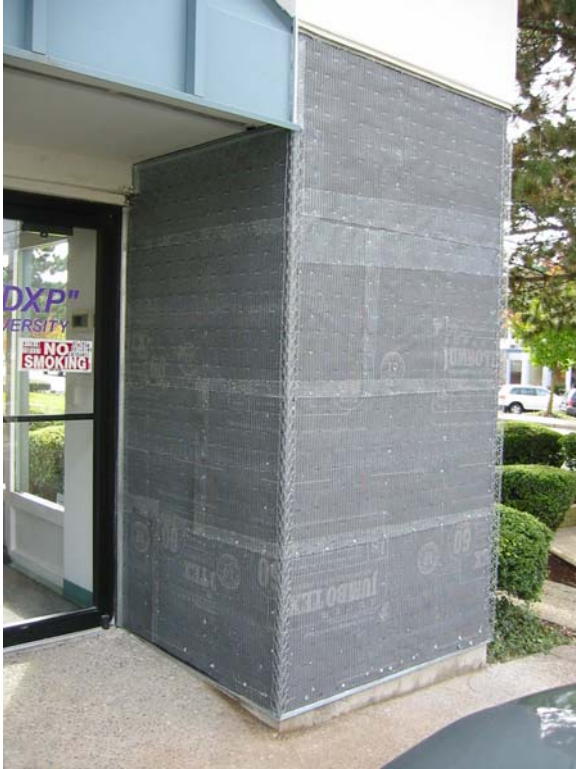
Description: After framing had been repaired and re-faced with OSB plywood a vapor barrier and chicken wire were re-installed to begin the stucco process.

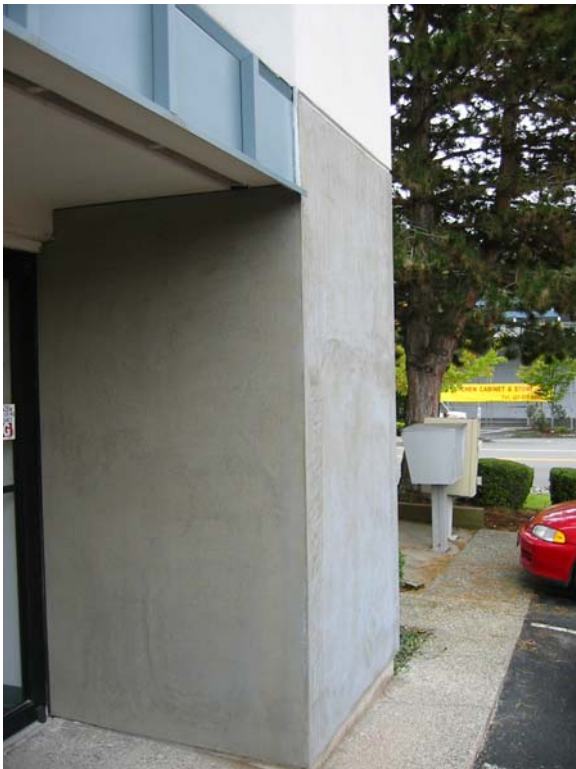
Description: After application of cement "mud" as a base layer for the stucco system. Skim coated 3 panels.

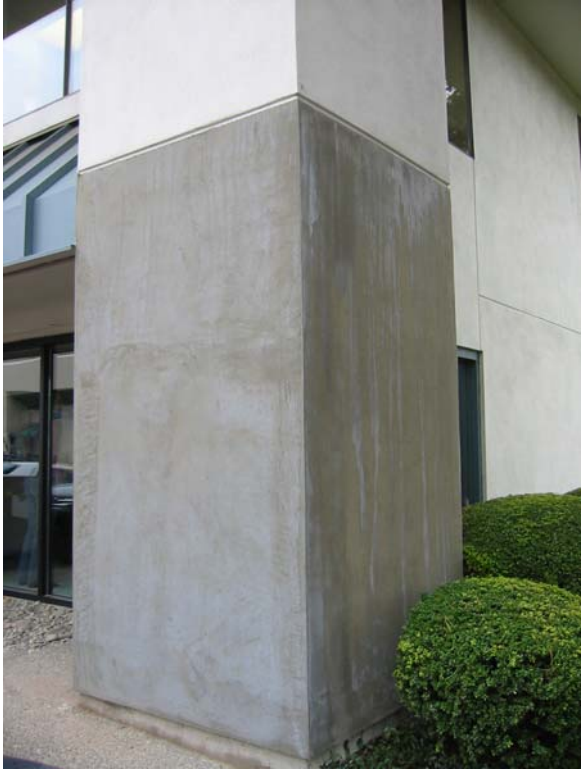
Description: Same as previous photo. Different angle. We had to skim coat the third side in order to do it right and "Make it look like it never happened".

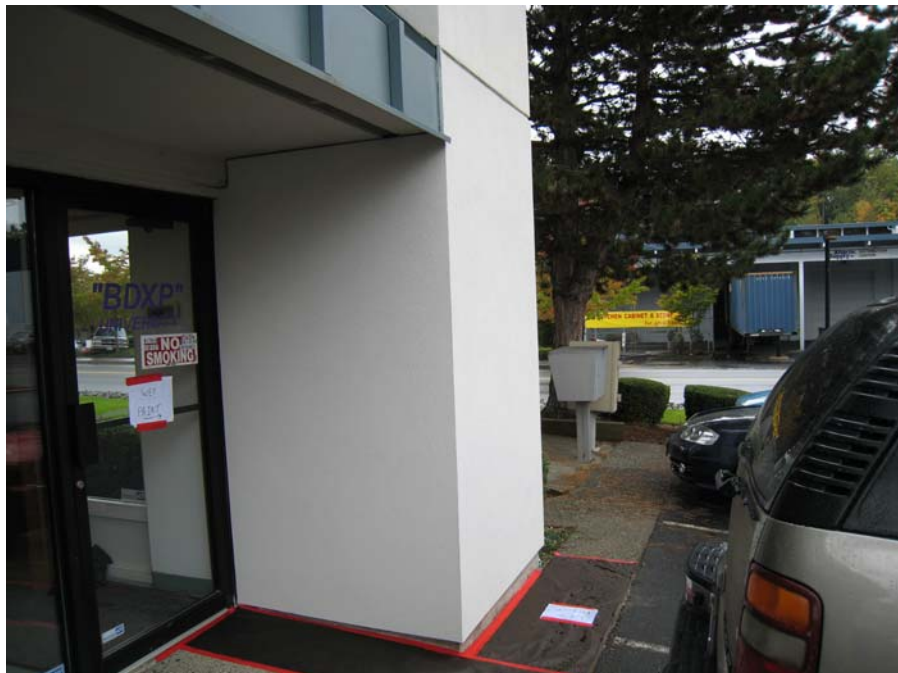
Description: Finish coat applied with texture color and matched to existing building color.

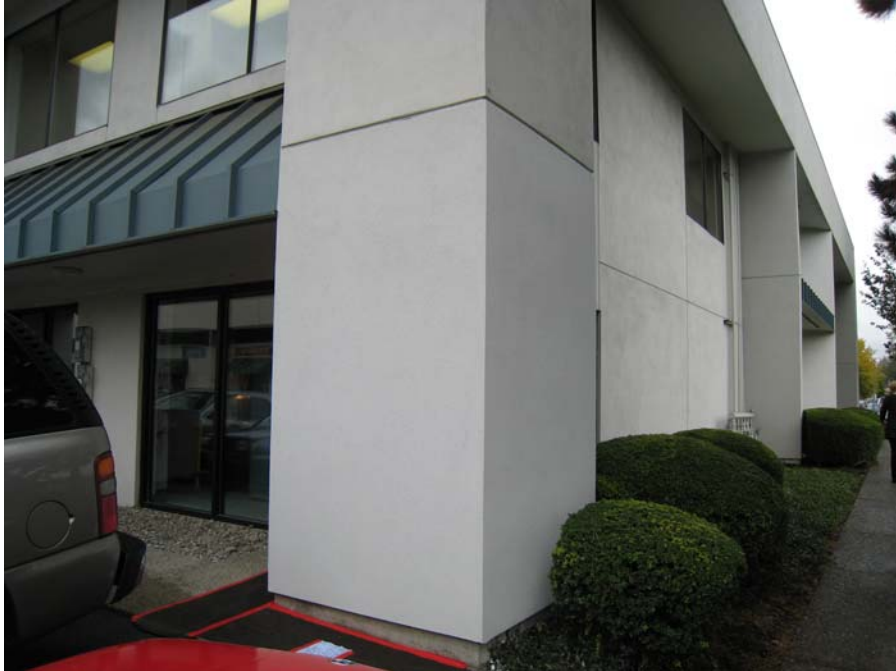
Description: Finish coat applied with texture and color matched to existing building color.

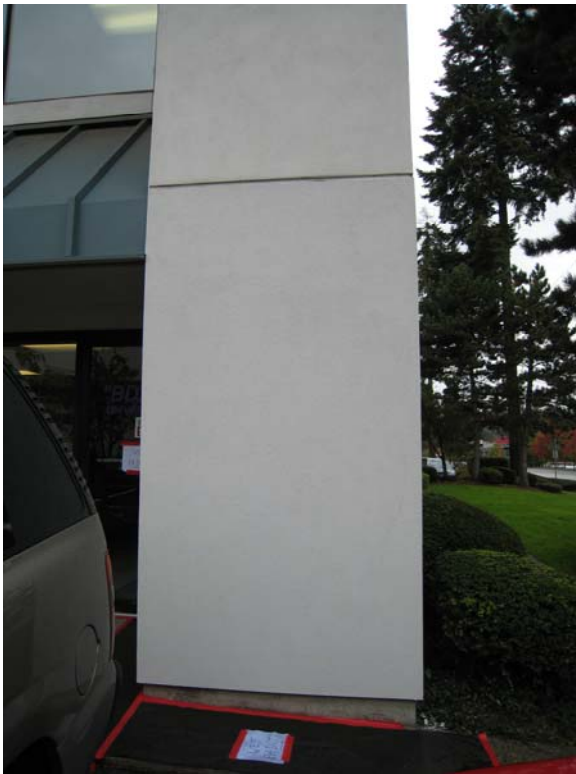
Description: Same as above. Finish coat applied with texture and color matched to existing building color.
