# Schafer Construction Project Summary

**Project Name:** Evergreen Building Products Tenant Improvement

**Project Description:** 10,618 SF of Office / Warehouse  
(724 SF Office / 9,894 SF Warehouse)

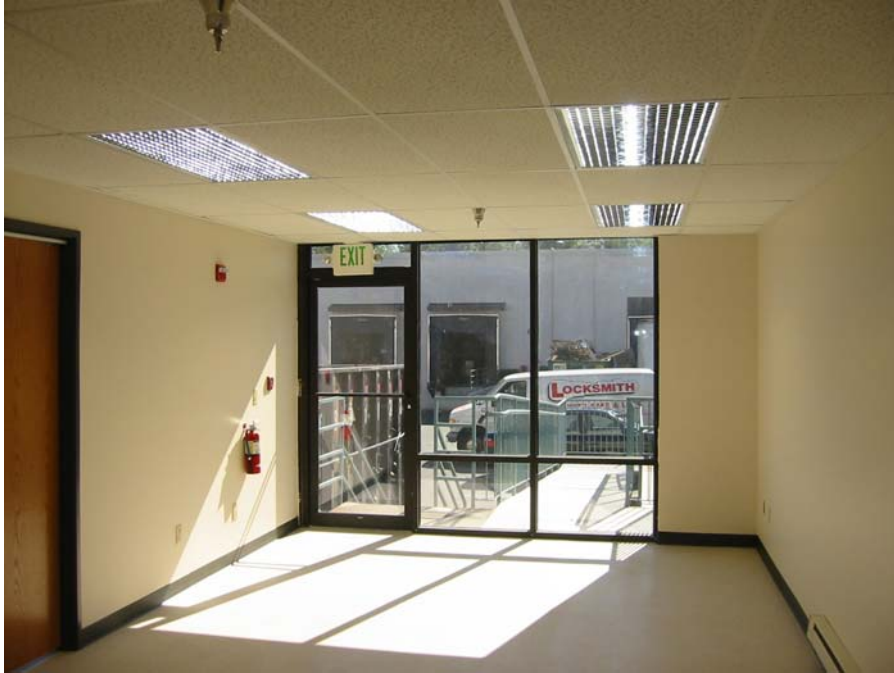
Description: Trade Space. Completed with VCT tile flooring, paint, solid oak doors, frames, door hardware, parabolic fluorescent light fixtures, baseboard heat, electrical, fire alarm system, ceiling tiles, insulation, base molding and new storefront installed.

**Office:** During demolition we tore off all sheetrock, suspended ceiling, light fixtures, vinyl floor, removed all fixtures from bathroom including partitions. We took the existing bathroom and created two single Men's and Woman's restrooms with heaters. We re-drywalled the entire space after making repairs to studs that had been damaged by forklift activity. Each bathroom was reconstructed with all new fixtures and granite countertops. New grid ceiling and fluorescent light fixtures were installed. The office was brought up to code for fire audible and visual. The entire storefront was also replaced. Upgrades to fire sprinkler system with quick response heads.

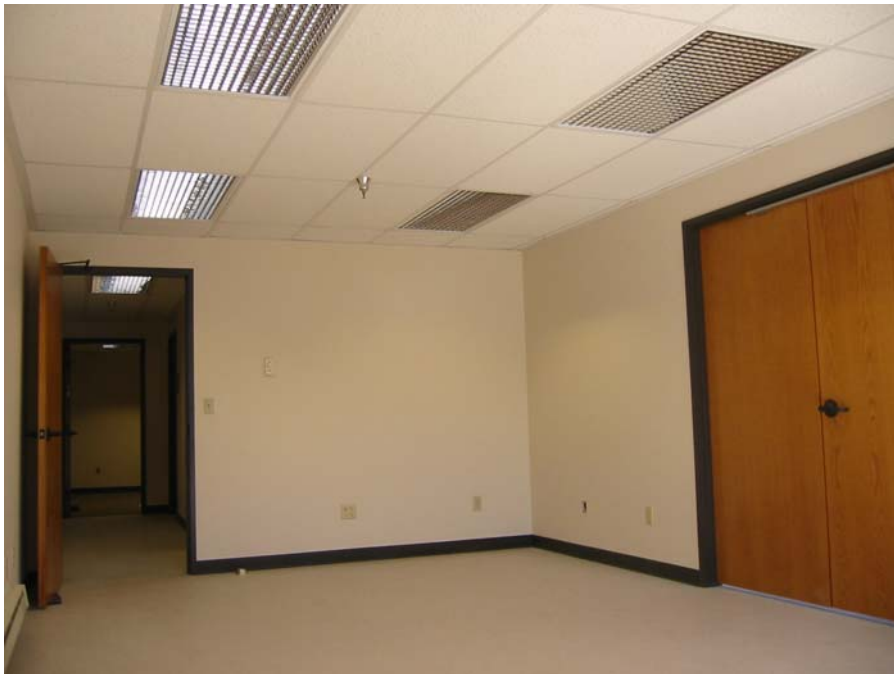
Description: Trade Space. Completed (see above)

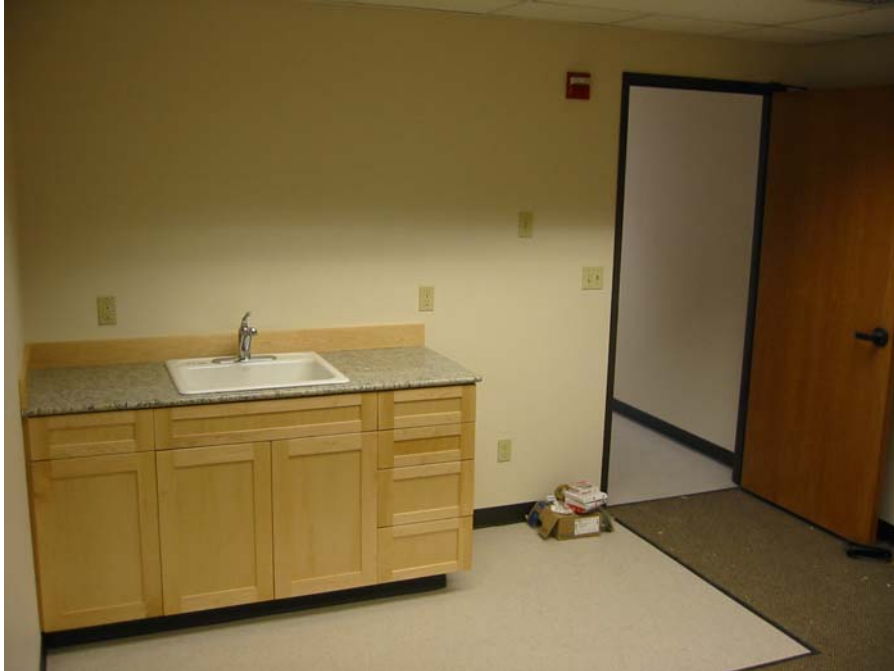
Description: Kitchenette. VCT Flooring around a small kitchenette with granite countertop. Carpet in the balance of the room.

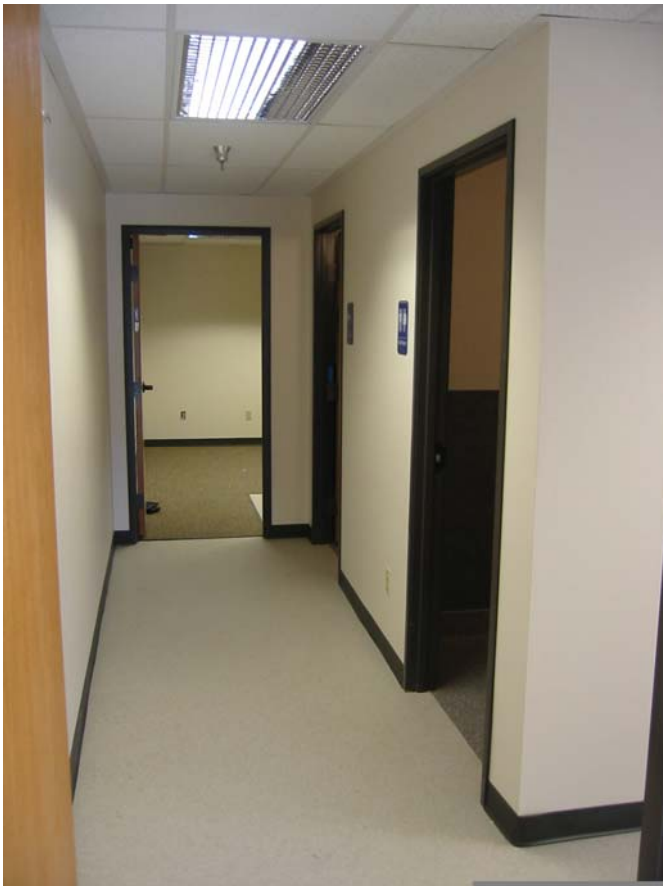
Description: Hallway looking from Trade Space. (see Trade Space Notes)

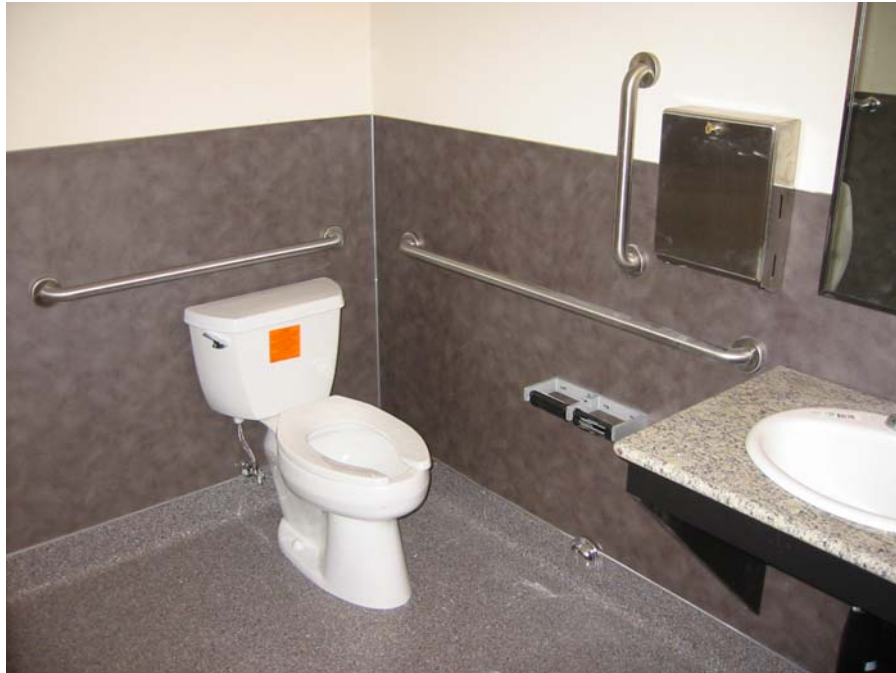
Description: Bathroom #1 ADA. All new fixtures, accessories, ADA grab bars and heater. Sheet vinyl flooring with wainscot. New granite counter and sink.

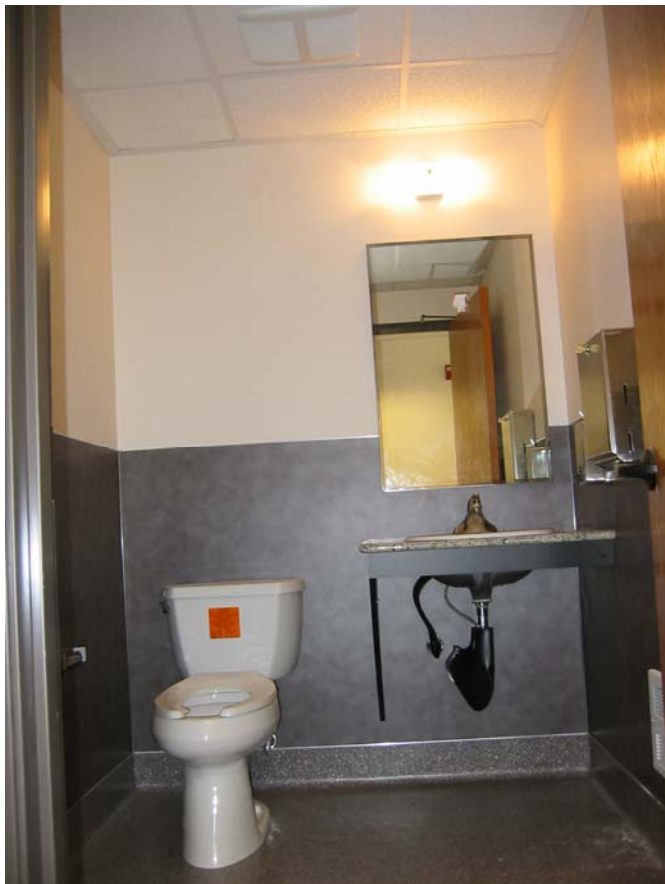
Description: Bathroom #2 Non-ADA. New fixtures, accessories, heater, granite counter and sink. Sheet vinyl flooring and wainscot.

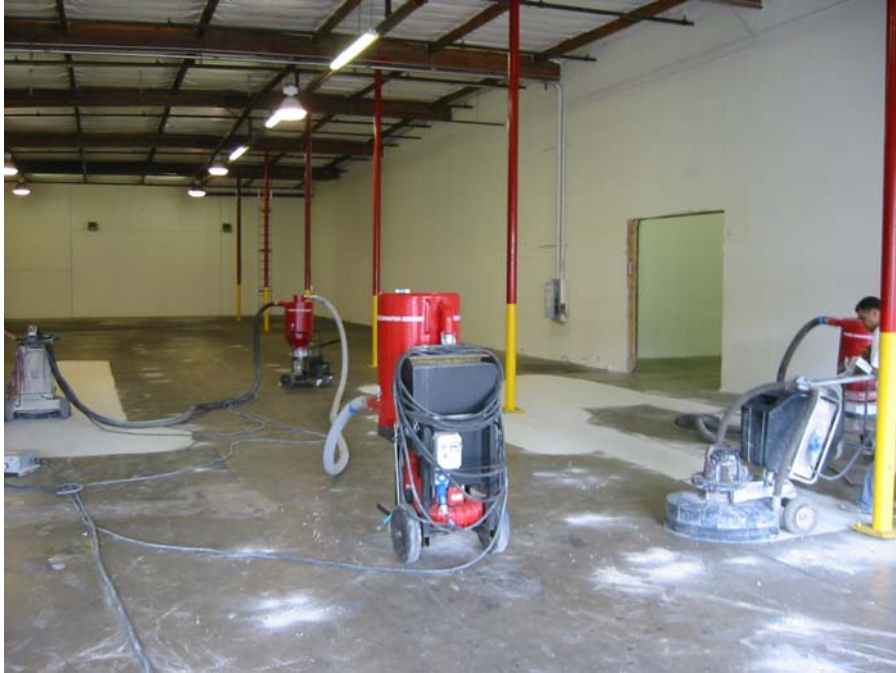
Description: Warehouse Floor. Start of diamond grinding. The difference is immediately noticeable.

**Warehouse** – The warehouse floor was re-surfaced by diamond grinding to remove the black appearance of the slab floor. Bolt holes and cracks in the concrete were filled then the entire warehouse floor was re-sealed with a penetrating sealer. The warehouse was brought up to code for fire audible and visual. A forklift ramp was installed and bolted to the dock edge.

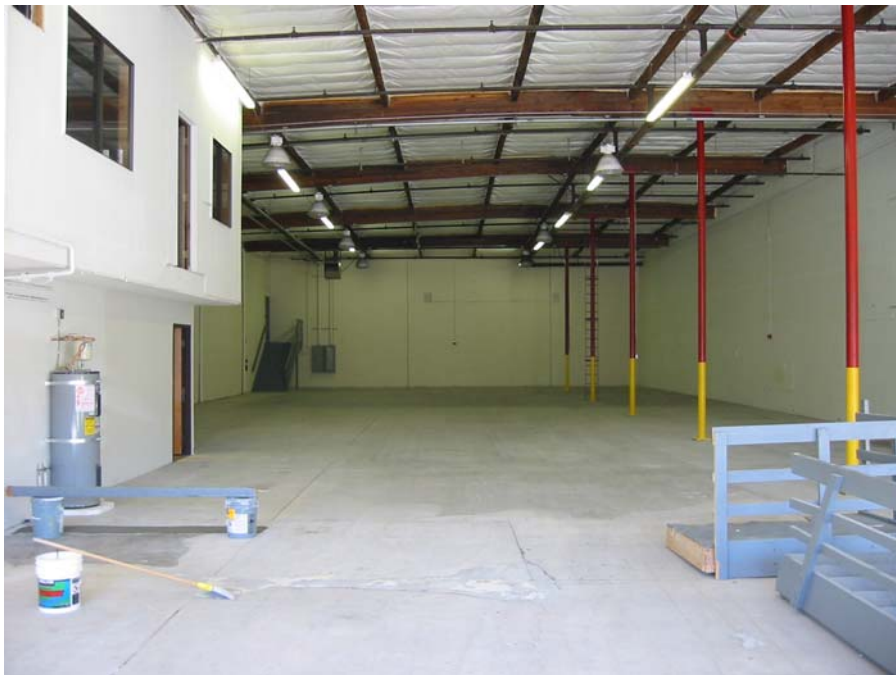
Description: Warehouse Floor. Completed and sealed.
